International Federation  
of Red Cross and Red Crescent Societies

**Shelter Research Unit**  
an initiative of the Benelux Red Cross Societies

This report focuses on the south of Bangladesh. The world's largest delta is hit regularly by cyclones and tropical storms causing loss of homes. There are issues with sheltering in the north as well, but this report is limited by the information that could be collected about the south. The response to cyclone Sidr, that hit Bangladesh in December of 2007, led to the construction and repair of thousands of shelters. It was also the first time that the Shelter Cluster was activated in the country. A lot of the information in this report stems from this operation. Secondly, this report is based on a mapping field study carried out by an IFRC SRU consultant in December 2011. The 17 shelters presented in the 'Bangladesh 17 Shelters' are a direct outcome of this mission. They are referred to regularly in this document, through coded pictures.

## Bangladesh - 17 Shelters

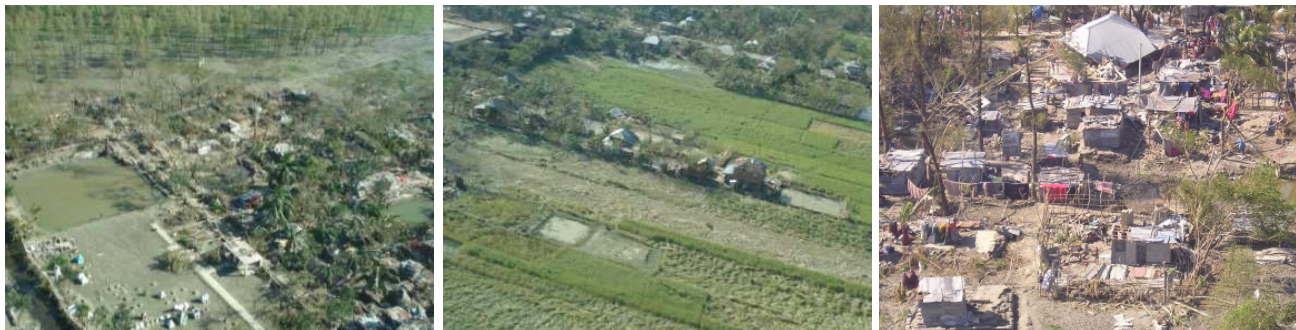
Homestead vegetation flattened from wind force and rain, crops flattened in the field, trees losing foliage. Longer flooding can pollute ground and water sources. Though vegetation around the house breaks the force of wind and water, the type of tree and its root system can be inappropriate causing trees to fall on housing.

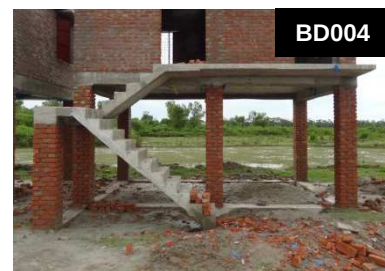
The above shelters have a strip foundation as their superstructure is out of brick and concrete. The last one has a pier foundation. This last type is vulnerable to buckling; proper reinforcement is crucial. Corner bracing could be added, whereas full length diagonal bracing could form an obstacle for debris dragged along in strong flooding.

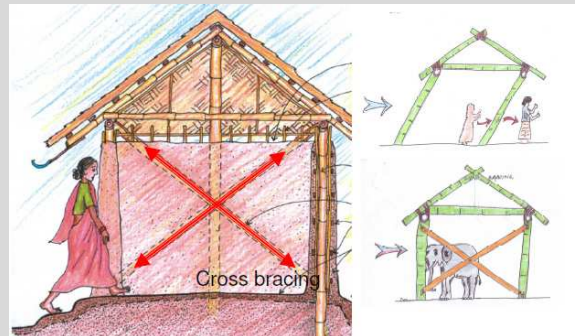
The scheme on the right hand shows what bracing should prevent: the falling over of the shelter under lateral wind forces. In many of the shelters this has been done by adding diagonals to the structure, as in the drawing. In all the planes of the structure this needs to be done, also in the roof. It can however also be done in other ways, such as the traditional construction technique of panelling. Also strong, stiff connections between structurally sound elements can be sufficient.

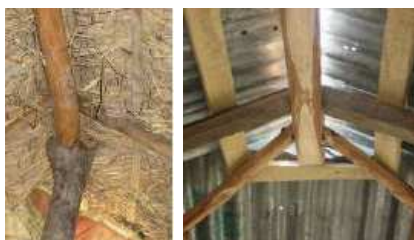
Less good examples on the left: timber poles simply resting on ceramic disks not connected to any type of foundation. Bottom left: Ridge beam resting on wood trunk column without proper connection. Bottom right: hipped roof without a rigid truss.

Better examples on the right: concrete pole with T-footing for more anchorage, trunk stumps sunk into the soil carrying the timber frame structure, purlin held down with metal strap, gusset plate to form a proper roof truss.

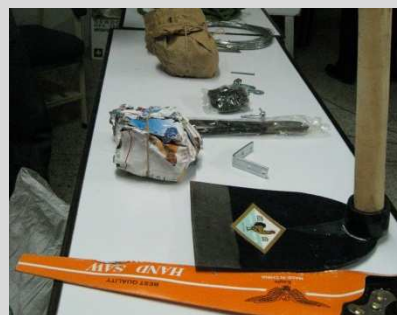
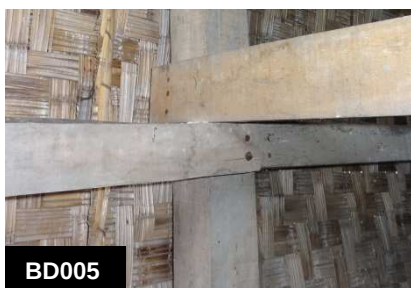
Left: a double bolt. Double diagonal nailing reaching deep enough can be rather lasting, but bolts generally hold better than nails. Right: a timber connection that is reinforced with a metal gusset plate. It creates a strong ridge connection. Below from left to right: overlap joint (with loss of section though), timber hung up in a metal connector, rafter to purlin with metal angles.

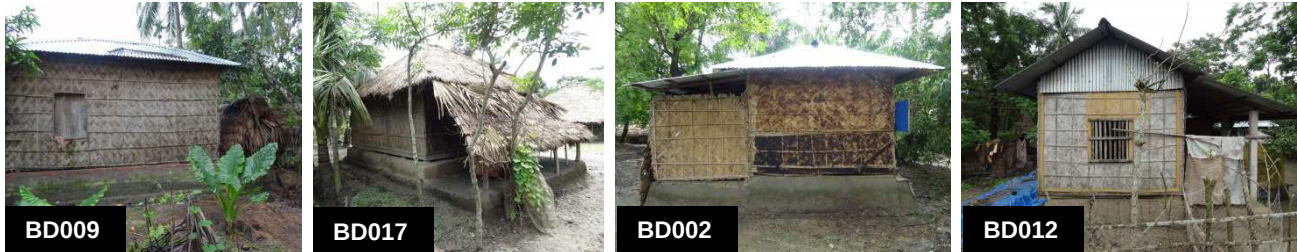
From left to right: simple untreated bamboo cladding, untreated bamboo cladding in a locally built shelter, bamboo cladding protected with bitumen in the lower parts most exposed to rainwater, bamboo mat with proper fixing and combined with tin sheets.

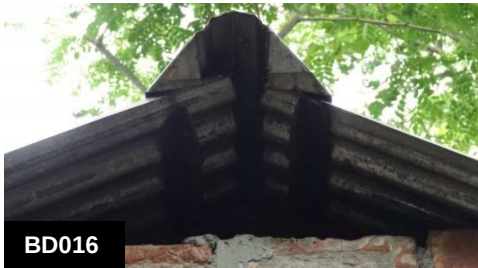
BD016

Tin sheets flying off during storms are hazardous. Their proper fixing is thus crucial. The rhythm of fixings in relation to the thickness of the sheets is the first aspect to take into account. They need to be regular enough, and multiplied near the edges of the roof. On the other hand, if there are too many fixings, the sheet is perforated too much and can be ripped off along the holes of the fixings. Secondly the type of fixing is important. Capped roofing nails to protect the holes are a minimum, screws are better. Holding down the purlins with J-bolts or metal straps is an extra precaution to be taken. Lastly the roof ridge needs to be properly fixed. The quality of the tin sheets (thickness, galvanisation or coating, quality of the base material) can vary and needs to be looked at as well.

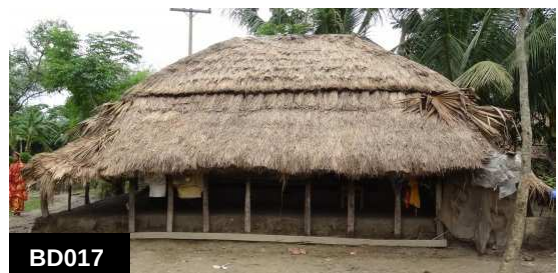
BD017

Thatch roofs, as the one in the picture right, in this climate are a good alternative for the problems mentioned. They regulate the climate in the house very well. It is however difficult to implement by agencies because of time shortage and procurement of this nor mass produced nor engineered material. Only a more intense participation by the beneficiaries can make this possible. This type of roof also needs more maintenance and repair.
