International Organization for Migration (IOM)  
The UN Migration Agency

## Rapid Shelter Assessment Report Sambava and Antalaha

Date: 21/03/2017

By: Joseph Ashmore (IOM Geneva), Giacomo Dei Rossi (IOM Madagascar)

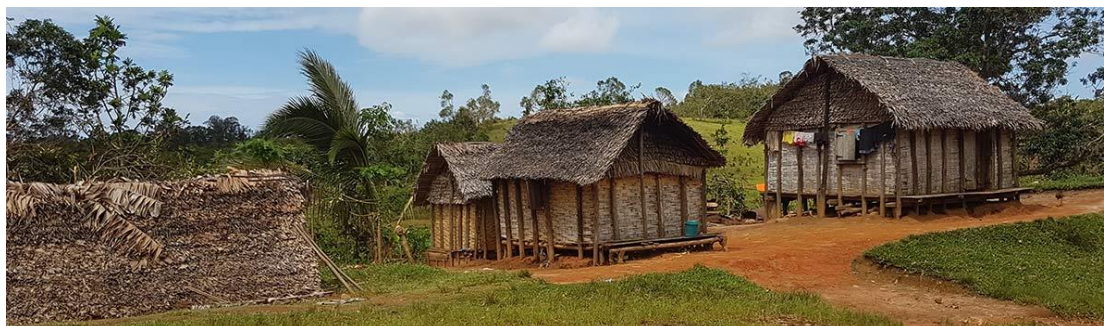
*Example of a family grouping of houses: the main house is on the right, a roof that was removed before the cyclone is on the left, a house for older children (centre), kitchen/granary (centre back), structure being rebuilt (behind the kitchen). Household size is 6 people.*

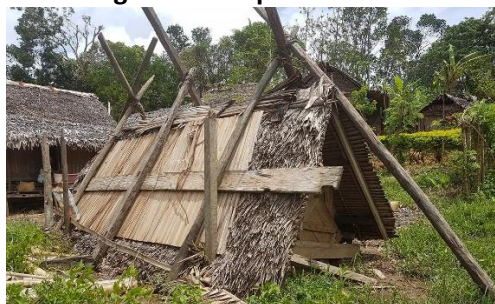
#### Removing walls and panels

*Above: Roof and wall materials have been removed to safeguard the materials and provide shelter during the storm*

Before the cyclone, many people removed roof and walls panels, putting them on the ground. In many cases the roofs were then used to make low level A-frame shelters under which people could survive the cyclone. After the cyclone roofs and wall panels are put back on the frame and damaged elements replaced. Several households are awaiting the end of the cyclone season before re-erecting their shelters.

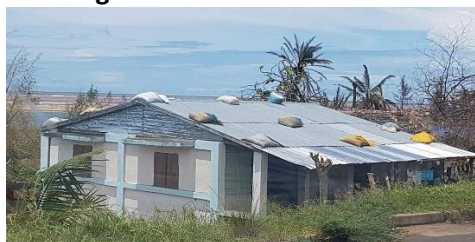
#### Sandbags on the roof

Sacks of soil or sand are often put on top of corrugated iron roofs to weigh down the sheets and prevent them from blowing away.

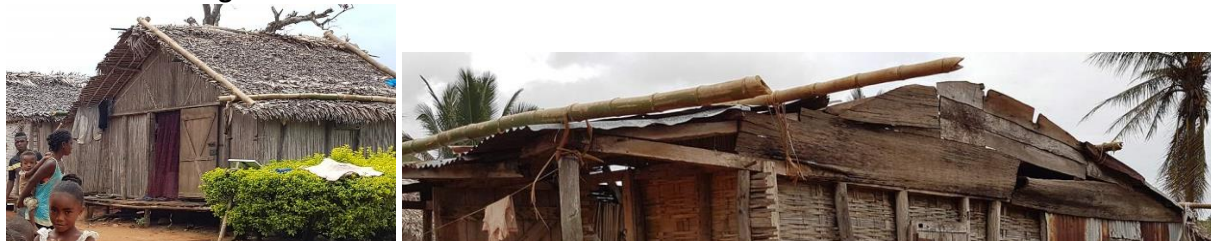
### Bamboo battening on thatched roofs

As in the photographs above, often some external bamboo battening was fixed along the eaves

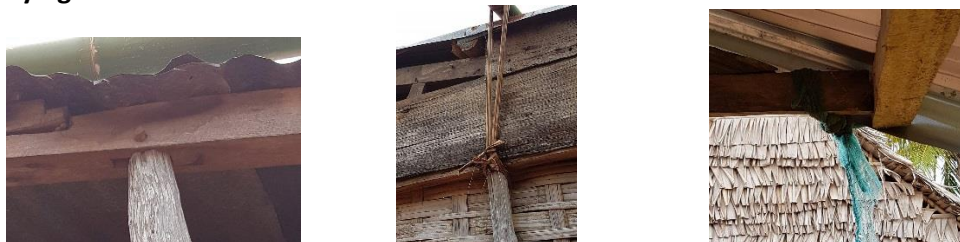
### Tying roof sections down

*Left: pegged joint joining the eaves to the post. Centre: tying down to a vertical post. Right: using netting to tie roofing battens to the eaves.*

Tying roof sections down to the vertical columns with string or netting. Often however, the tie downs were not consistent across all joints that would experience force or were of inadequate materials. In some cases people used wooden pegs.

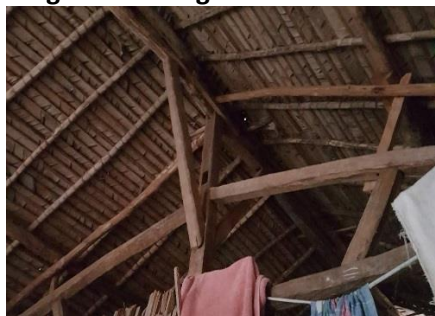
### Diagonal bracing in the roof

A minority of structures had internal diagonal roofing bracing. This is a good practice and should be replicated.

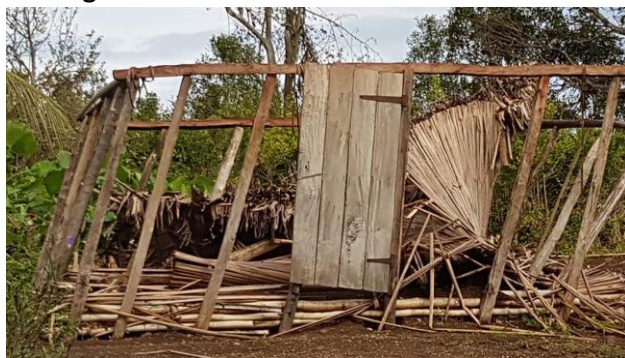
#### **Bracing the walls structures**

*Shelter failure showing racking*

Many of the shelters used bamboo or wooden cladding to make rigid walls reducing the need for bracing in the walls. However, often posts are buried insufficiently or rotten, and the cladding old or insufficiently fixed to create rigid walls.

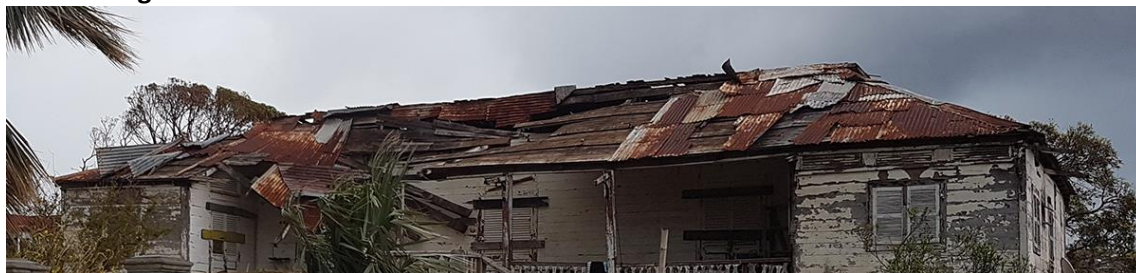
#### **Poor nailing of CGI**

*Failure of corrugated iron roofing*

Many of the Corrugated Iron roofs – particularly verandas were poorly nailed down and hence failed. Additionally failure of Corrugated Iron roofs was caused by old sheets and lack of timber framing.

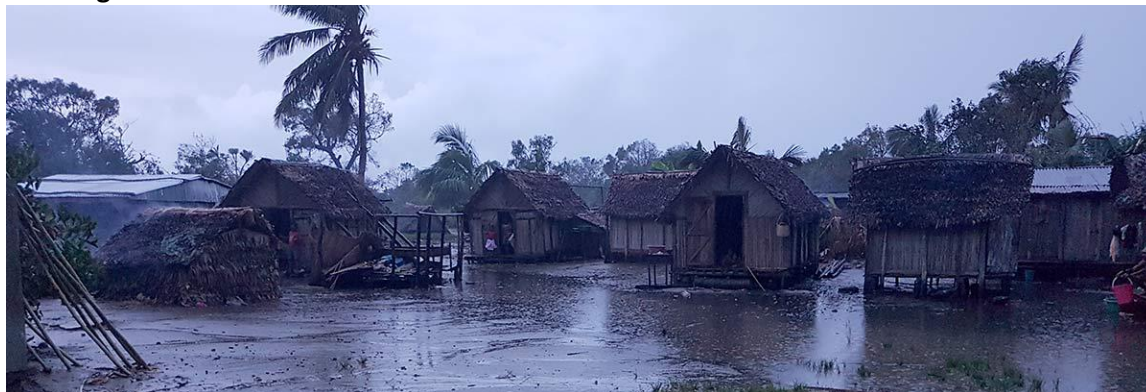
## **Flooding**

*A village that floods regularly with heavy rains. To some degree raised floors mitigate this hazard.*

Flooding was primarily due to locations of shelters, and mitigation was conducted by the construction of raised plinths or floors. In many case rain water could be drained quicker by construction of simple drainage and improved plinths. In many cases this is an annually recurring issue.

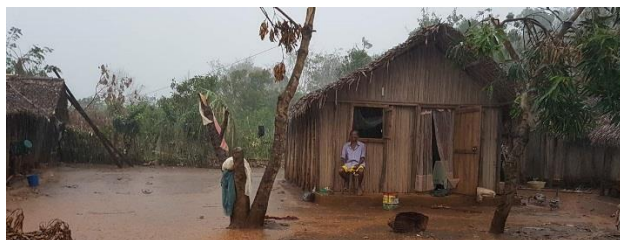
*This house has a concrete plinth and uses solid panel made from Ravanales for the walls. These were well tied in and lead to lateral stability. However lack of maintenance or old timbers would lose the stability and the structure would risk racking.*

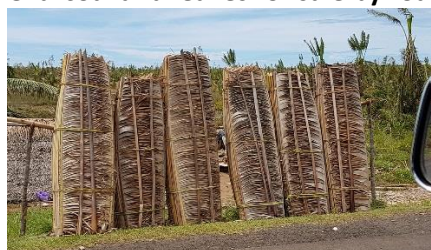
##### **Charcoal and leaves for sale by road** (S14°34.387 E 50°09.930):

*Leaves for thatching roofs are available, but very locally and in limited volumes*
