# House Damage Technical Assessment Report

Global **Shelter Cluster**

Taiz Gov

Implementer: Nahda Makers

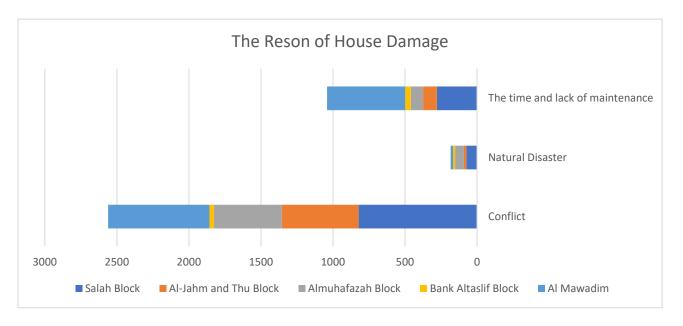
Chart 6-18

The graph illustrates the reasons for house damage across different blocks, categorizing the primary causes as conflict, natural disaster, and the time and lack of maintenance. It highlights the frequency of each reason in relation to the overall damage reported.

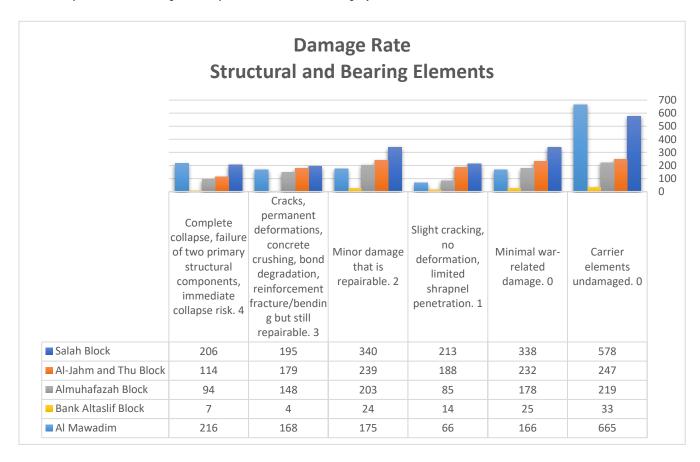
Chart 6-20

This graph illustrates the damage rates of structural and bearing elements across different blocks, categorizing the types of damage from complete collapse to undamaged carrier elements. The data highlights the frequency of various damage levels, including complete collapse, significant cracks, minor repairable damage, and instances of undamaged carrier elements. Each block is represented, allowing for comparison of structural integrity across the assessed areas.

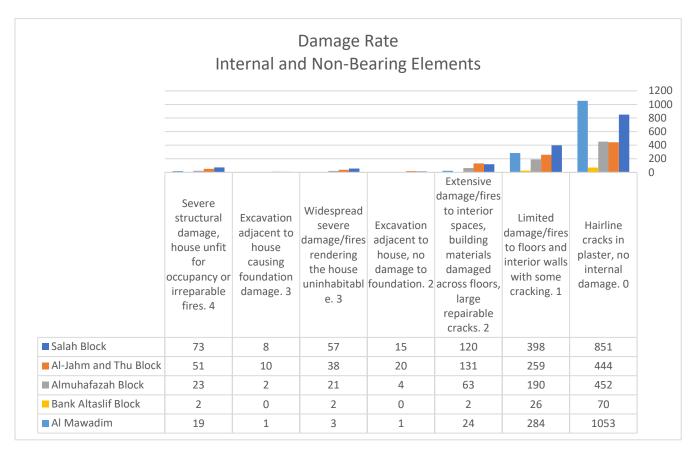
Chart 6-21

This graph presents the damage rates of internal and non-bearing elements across different blocks, categorizing the types of damage from severe structural issues rendering houses uninhabitable to minimal hairline cracks. The data highlights the frequency of various damage levels, including extensive internal damage, excavation impacts, and conditions that are still repairable. Each block is represented, facilitating comparison of the state of internal and non-bearing elements across the assessed areas.

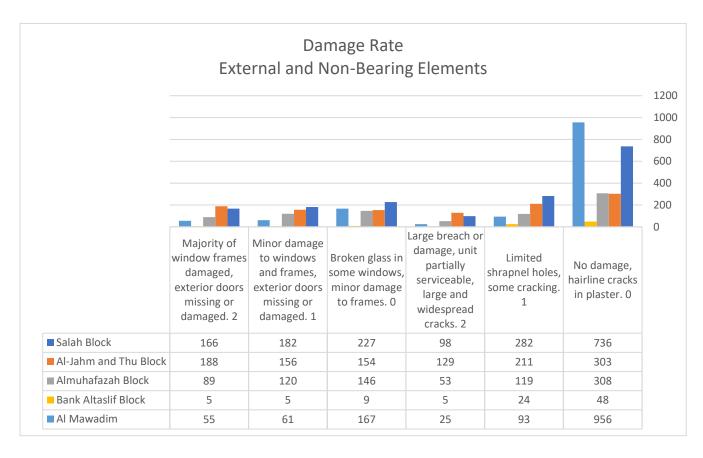
Chart 6-22

This graph illustrates the damage rates of external and non-bearing elements across various blocks, detailing the extent of damage from minor issues such as window frame damage to significant breaches affecting the overall structural integrity. The data categorizes the frequency of different damage levels, providing a comparative overview of the condition of external and non-bearing elements across the assessed areas.

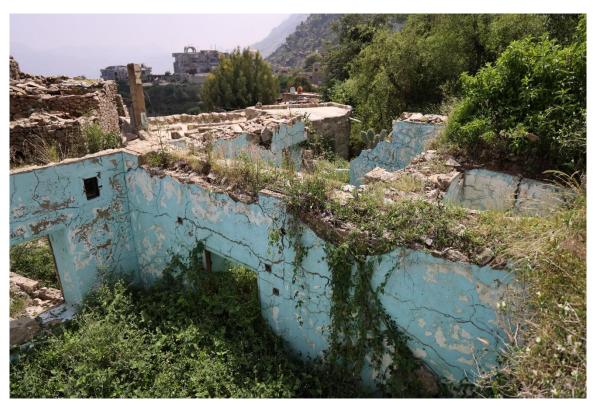
Fig 11-2 Fully damaged houses in Saber Al Mawadim, Taiz, overgrown with vegetation and deemed unsuitable for living.

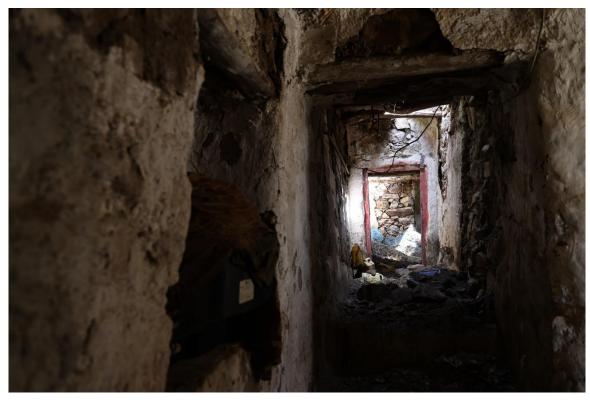
Fig 11-4 An abandoned old house in Saber Al Mawadim, left by its owners due to the impact of war, now stands in disrepair and is unsuitable for living.

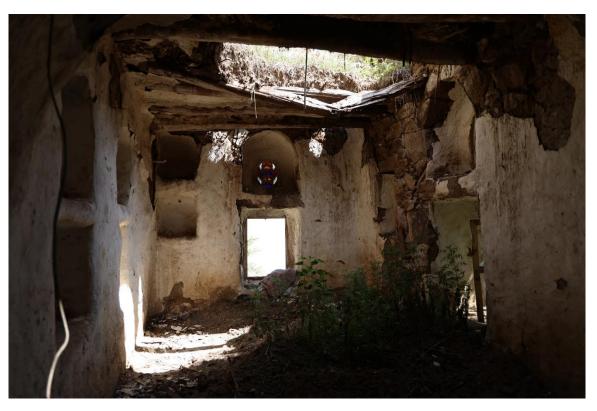
Fig 11-5 Inside an abandoned house in Saber Al Mawadim, the remnants of a once lively home reveal the impact of war, with sunlight streaming through openings and vegetation reclaiming the space.

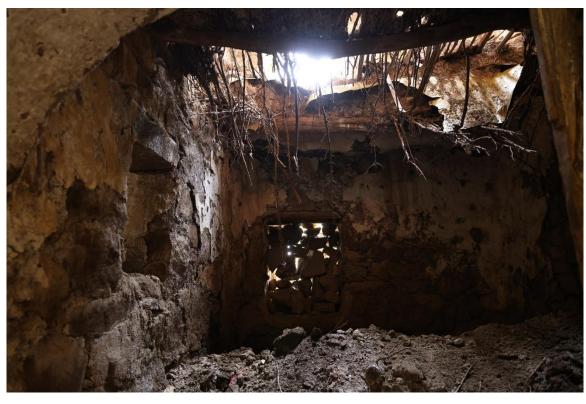
Fig 11-6 Inside another room of the abandoned house in Saber Al Mawadim, sunlight filters through the crumbling roof and a broken window, casting eerie shadows on the walls and revealing the remnants of a once-vibrant space now overtaken by nature.

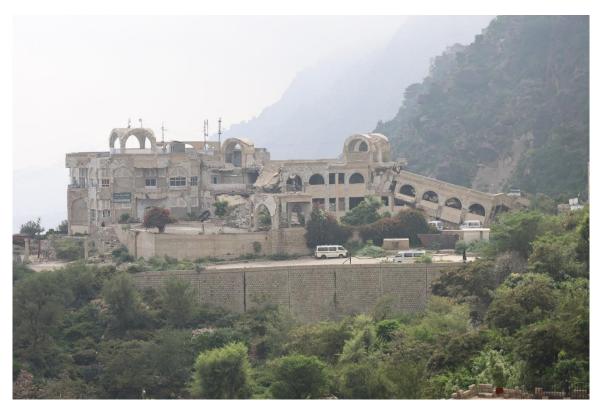
Fig 11-7 This once-popular public resting and viewing building in Saber Al Mawadim, Taiz, Now lies in ruins, heavily damaged by air strikes during the war, a stark reminder of the conflict's impact on the community.

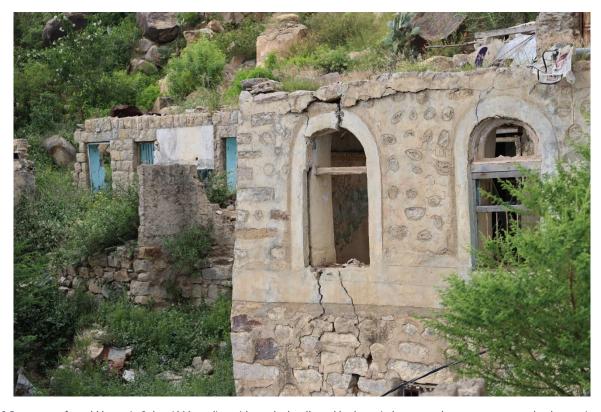
Fig 11-8 Remnants of an old home in Saber Al Mawadim, with cracked walls and broken windows, stand as a testament to the destruction wrought by war, now overrun by nature and time.

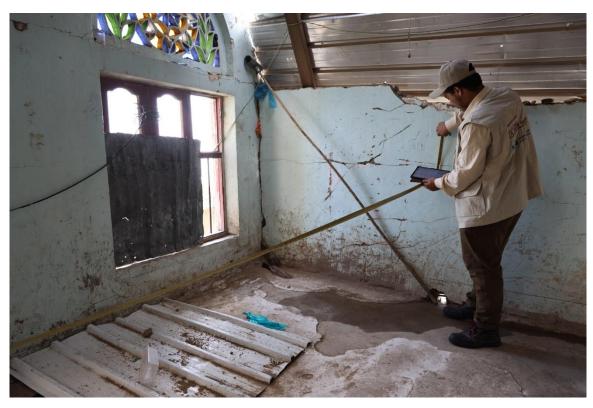
Fig 11-9 NMO engineer conducts a technical assessment of a damaged room in a house in Saber Al Mawadim, Taiz, which has become uninhabitable due to war. While the house owner resides in a safer area of the home, this section is no longer suitable for living.

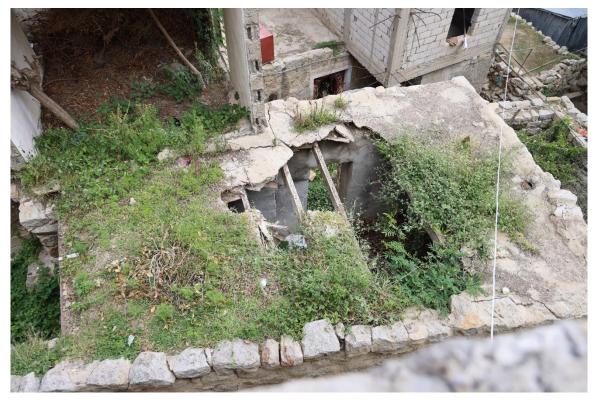
Fig 11-10 An overview of a deteriorating structure in Saber Al Mawadim, Taiz, where nature is reclaiming the space. The roof has collapsed, and vegetation now flourishes in the once-occupied area, highlighting the impact of abandonment and the effects of war.

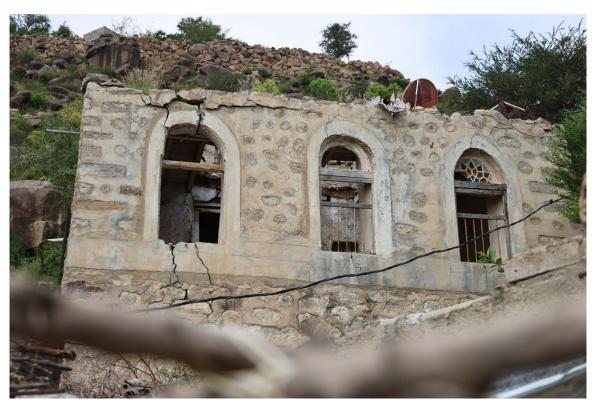
Fig 11-11 Cracked and weathered, the facade of an abandoned house in Saber Al Mawadim, Taiz, reflects the toll of conflict. The remnants of its architectural beauty stand in stark contrast to the neglect and devastation surrounding it.

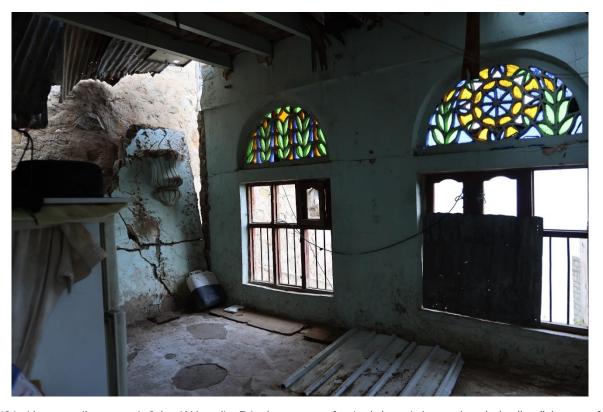
Fig 11-12 Inside a once vibrant room in Saber Al Mawadim, Taiz, the remnants of stained glass windows and cracked walls tell the story of a home damaged by armed clashes during the war. The side wall has collapsed, leaning precariously against the nearby mountain.

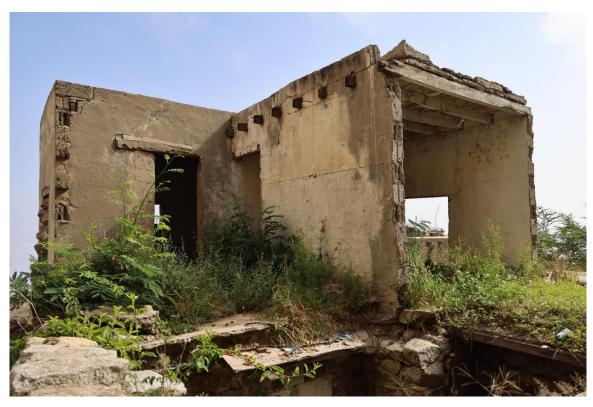
Fig 11-13 Remnants of a building in Saber Al Mawadim, Taiz, stand in stark contrast to the encroaching vegetation. The structure, abandoned and damaged by the war, reveals open doorways and collapsed sections, symbolizing the ongoing impact of conflict on the community.

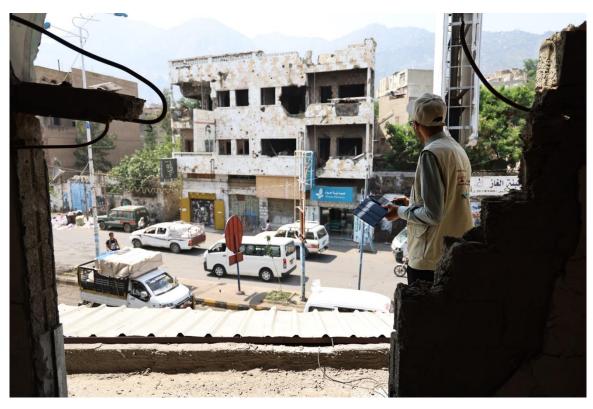
Fig 11-15 From a damaged building overlooking one of the most impacted main streets in Salah, Taiz, an NMO engineer evaluates the extent of destruction. Both sides of the street bear the scars of war, with buildings visibly damaged and in disrepair, underscoring the urgent need for rehabilitation and support in the community.

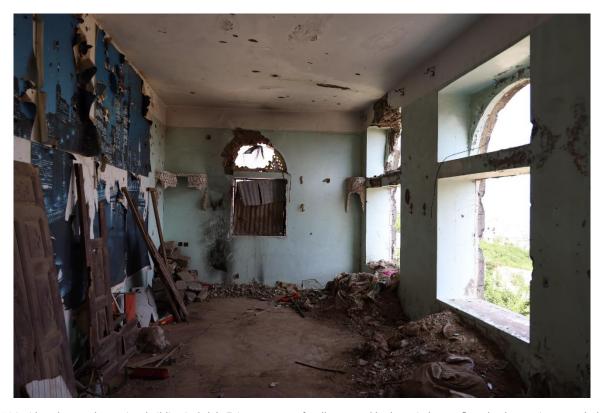
Fig 11-16 Inside a damaged room in a building in Salah, Taiz, remnants of wallpaper and broken windows reflect the destruction wrought by war. The debris scattered across the floor and the exposed walls tell a story of neglect and the urgent need for reconstruction.

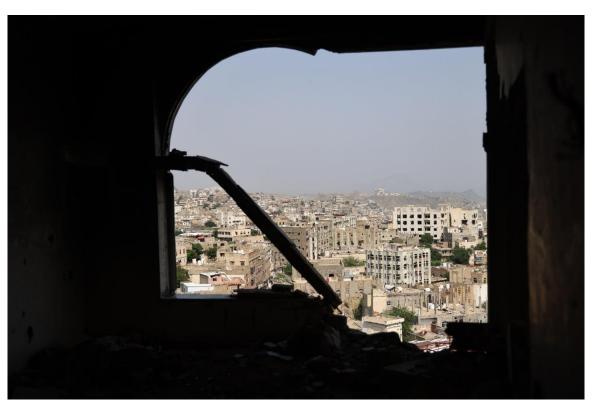
Fig 11-17 View from a damaged window in a building in Salah, Taiz, overlooking the war-torn landscape. The ruins of nearby structures reflect the impact of conflict on the community, showcasing the need for urgent rehabilitation efforts.

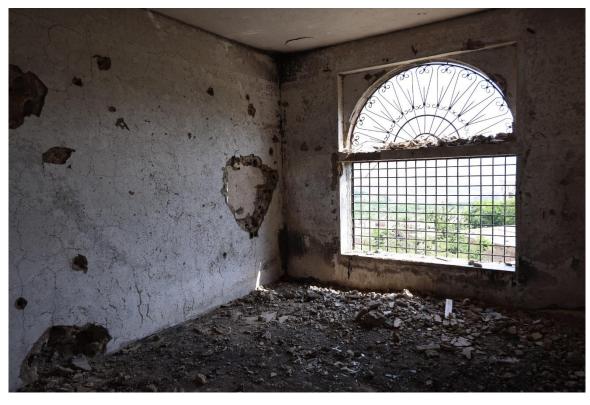
Fig 11-18 Inside another damaged room in Salah, Taiz, the walls bear the scars of conflict with visible cracks and debris scattered across the floor. The light filtering through the broken window highlights the extent of neglect and the urgent need for restoration.

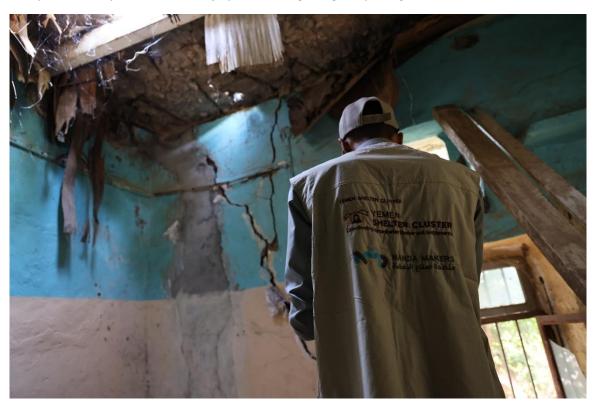
Fig 11-20 NMO engineer conducts a thorough assessment in a damaged room in Salah, Taiz. The visible deterioration of the ceiling and walls underscores the severe impact of armed conflict, highlighting the critical need for intervention and support from the shelter cluster.
