International Federation  
of Red Cross and Red Crescent Societies

**Shelter Research Unit**  
an initiative of the Benelux Red Cross Societies

This report focuses on the south of Bangladesh. The world's largest delta is hit regularly by cyclones and tropical storms causing loss of homes. There are issues with sheltering in the north as well, but this report is limited by the information that could be collected about the south. The response to cyclone Sidr, that hit Bangladesh in December of 2007, led to the construction and repair of thousands of shelters. It was also the first time that the Shelter Cluster was activated in the country. A lot of the information in this report stems from this operation. Secondly, this report is based on a mapping field study carried out by an IFRC SRU consultant in December 2011. The 17 shelters presented in the 'Bangladesh 17 Shelters' are a direct outcome of this mission. They are referred to regularly in this document, through coded pictures.

## Bangladesh - 17 Shelters

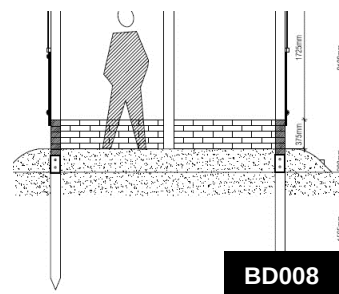
Since the use of RCC is not common in Bangladesh it is difficult to guarantee qualitative work. Some actors set up their own production units for prefabricating poles; others ordered them prefabricated from urban centres where RCC techniques are better known. Unfortunately not all projects attained the desired level of quality. It is crucial that this part of the construction is supervised well.

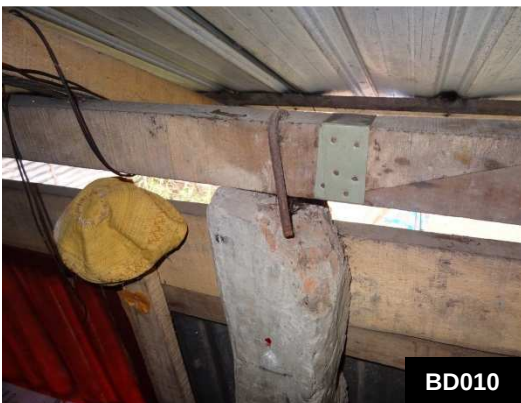
BD010

Many of the shelters are built with reinforced concrete columns. Though this is certainly a viable technique, and preferred by most people, there are some risks involved. Firstly the saline environment is not mild on concrete and any reinforcement bars that are exposed. Secondly, the materials to produce good quality RCC are not easily available. Water is often saline or not free of organic material. Sand and other aggregate is possibly abundant in the delta, but is often neither pure nor strong enough. Since the people are not used to this material the execution can also be problematic; the positioning of the reinforcement bars should allow for enough coverage, the mixture needs to have the right and an even consistency, the concrete needs to be compacted properly. Most villages lack electricity, so the tools that can be used are limited.

Lastly, transport of heavy columns is possible but not easy. Some projects included women headed households who struggled to organise transport of these columns to their plot. **In conclusion, using RCC is one of the options preferred by agencies, but close attention should be paid to quality throughout the whole construction process.**

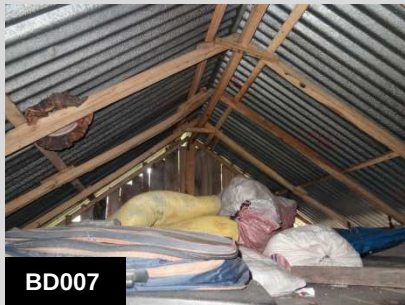
BD007

Top left: a light purlin and rafter structure in small sections without reinforcement measures. Top right: same, but with addition of a king post. Side left: timber truss with cross bracing in horizontal and roof planes, joints reinforced with metal plates.

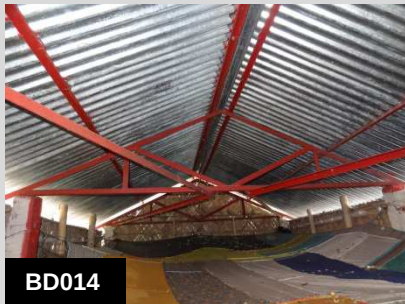
BD014

Left: a quite light steel angle truss, though with cross bracing in the horizontal plane and in the vertical trusses, bolted together. Right: a heavier steel angle truss structure where the connections are formed with metal plates.

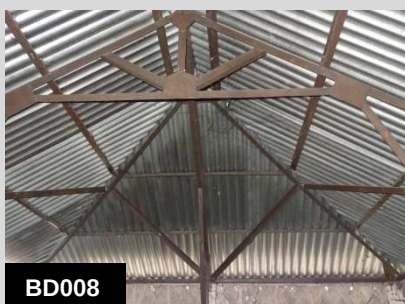
BD008

Only one shelter has a hipped roof in steel angle. This roof was purposely designed to offer extra height in the house for storage, safe area and allowing construction of lower surrounding verandas as is the local practice. Trusses were pre-fabricated, welded, and bolted together on site.

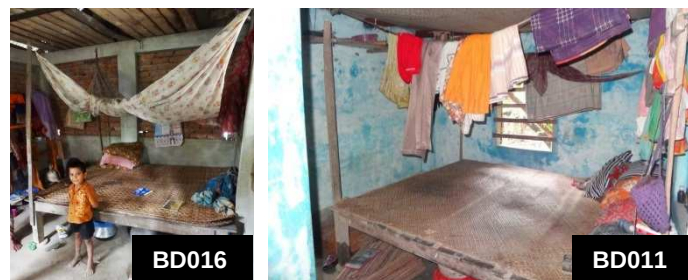
On the right two shelters with masonry walls. In the first one, the brick masonry wall was not further finished on the inside. In the one on the extreme right the walls have been plastered and painted. In this saline environment with limited skills in cement works, the durability of the plastering could prove to be problematic.

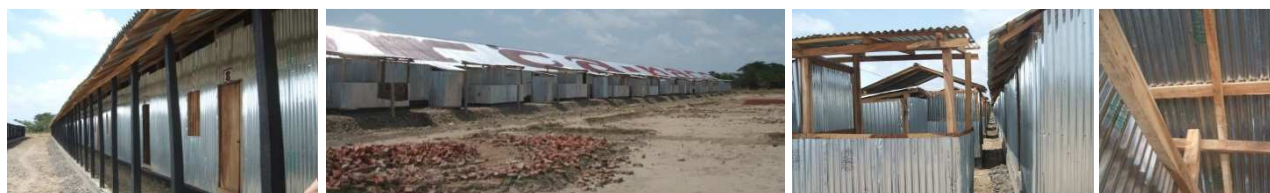
Below a largely unoccupied housing resettlement scheme.

Many resettlement and relocation projects in Bangladesh suffer from typical problems encountered with this type of projects. Houses are built on locations that are too far from income generating opportunities or with insufficient consideration for the creation of a pleasant living environment (problems of privacy, lack of or insufficient services, no privately useable outside space, no greenery etc.). This type of projects is extremely complex; a viable living environment with all its aspects needs to be created from scratch. To do it well, a lot of time and effort is needed, even outside of disaster times.

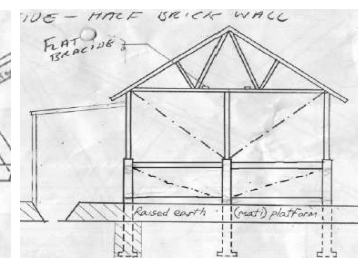
RCC pole foundations reach about 1m above the raised mud plinth level. A furthermore timber structure was bolted to the poles. Tie down and cross bracing have been provided, joints are reinforced with metal plates.

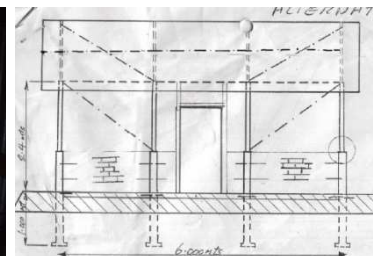
Both walls and roof are covered with tin sheets. This has the benefit that the house can be completely closed down during storms, but can pose problems of lack of ventilation. Only the front side of the house has a door. Three windows were included. Windows and doors are out of tin sheet as well so the shelter can be closed down completely.

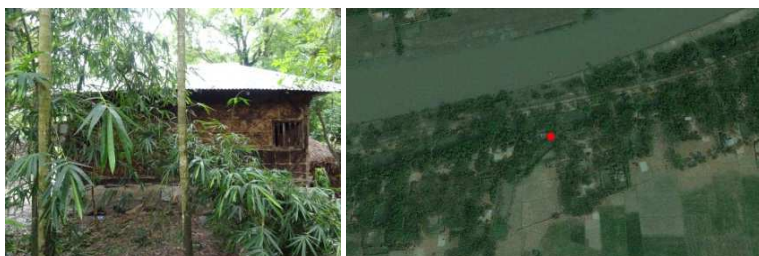
This shelter was built on the plot where the house was standing on previously. It is located in a type of residential 'ribbon' development along a river. It is higher up from the low-lying rice fields south of the house, and is surrounded by sturdy vegetation.

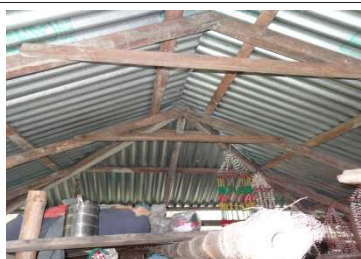
14 RC poles, many but rather slender, support a timber hipped roof. Hipped roofs resist strong winds better. Also the rectangular design is beneficial; the wind can easily go around the house. Cross bracing at wall level and in the roof and tie down from the roof down to the foundation are foreseen, but it is a bit minimal. The mud plinth suffers from rain and was somewhat protected by covering with bags.

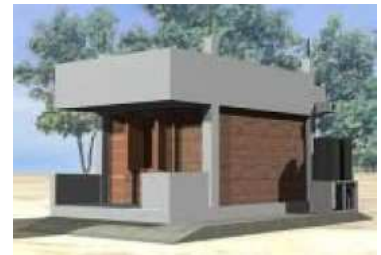
A reinforced concrete column structure is filled in with brick wall. The shelter has a flat concrete roof structure. Heavier structures tend to resist heavy winds more easily. The raised concrete floor slab on a brick perimeter wall helps to resist flooding. In terms of design and materials used, this is an extraordinary shelter for the context. Issues will rather be with comfort of living rather than with strength (if built well). Secondly, adaptability and maintenance may be a problem, since local people are not accustomed to work with these materials and design.

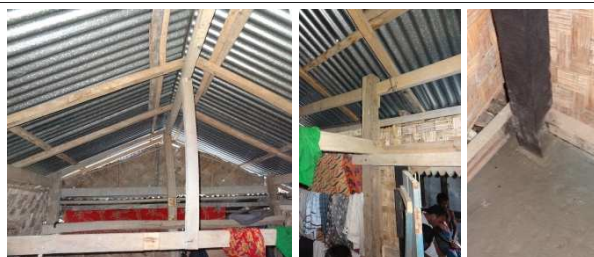
The foundation consists of 4 concrete poles reaching up to plinth level. To those poles a timber frame is attached. The short poles leave the lower sections of the timber frame vulnerable to humidity. A horizontal wooden band in lapped joints binds the structure just above plinth level and just under roof level. Though cross-bracing in the roof is part of the original design, this was not seen during survey. The roof structure is quite light.

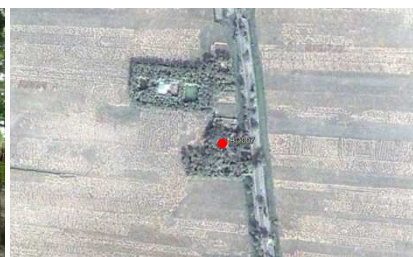
The shelter was built on the plot where the family's house was previously located on. The garden is thus fully planted and gives the house some supplementary resistance to flooding and wind. The plot is however not part of a larger ribbon or cluster development, but lays in a flat and open low-lying plane increasing the vulnerability of the house.

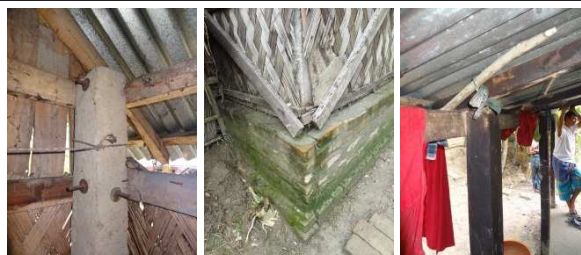
The raised plinth has been reinforced by some layers of masonry. An RC column supports the structure in each of the 4 corners of this shelter. The rest of the structure is out of timber with supplementary columns mid width, columns to support a veranda and externally fixed timber for cross-bracing in the wall plane. The gable shaped roof is also out of timber, but is rather weak in terms of wind resistant design.

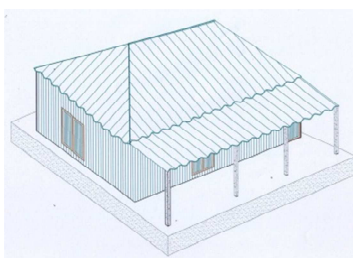
The central shelter was clad with tin sheets for roof and walling. Those used for the wall were painted to resist the saline environment better. The all-round use of tin sheets may cause issues with climate (heat and lesser ventilation) and noise inside the shelter. In building the extensions, the inhabitants provided for ventilation by keeping the upper parts of the walls open or half-open. The central shelter counted 1 door and 3 or 4 windows.

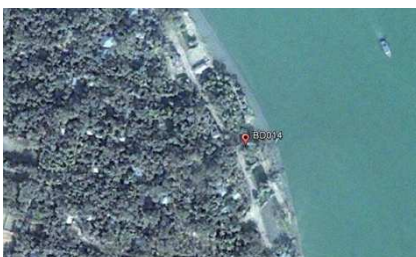
Right on the riverbank, this plot is very vulnerable to impact from storms and cyclones; impact from wind, floods and surges. Though the shelter is built on a fully planted plot, where the previous house was on, in a rather dense residential cluster, the closeness of the river is crucial; where and how a river embankment is built in relation to the site.

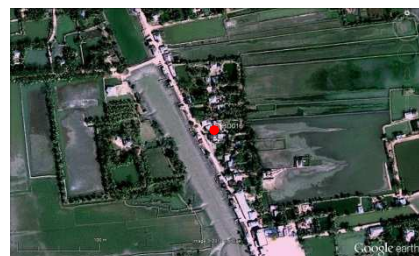
This shelter is built on the plot where the destroyed house of this family was previously located on. The site is part of a thin residential ribbon. A half-closed canopy provides some breakage of wind forces, but this could be improved.

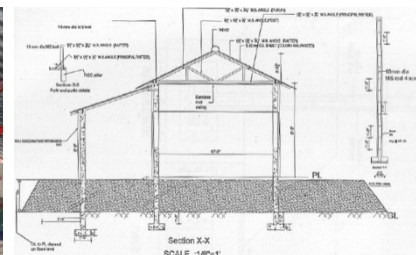
9 RC columns with footing support a metal truss roof structure. The plinth has been raised. The columns and roof structure are quite slender and light, but do include cross bracing and tie down.
